Damage Mechanisms Affecting Fixed Equipment in the Refining Industry

API RECOMMENDED PRACTICE 571
SECOND EDITION, APRIL 2011

Downstream Segment

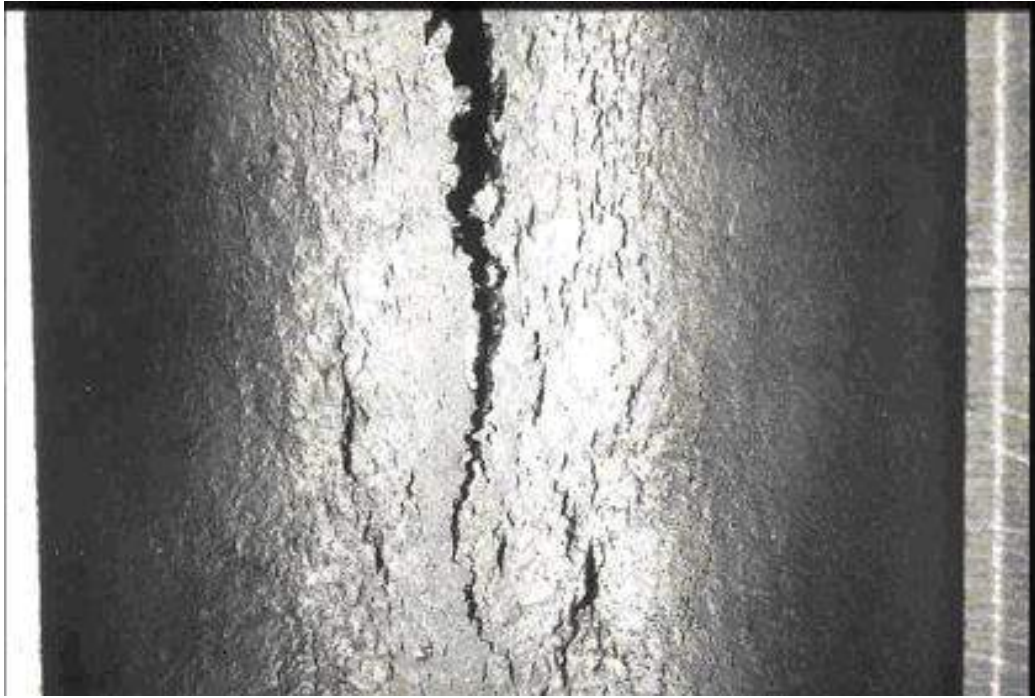
Figure 4-18 – Creep rupture of an HK40 heater tube.

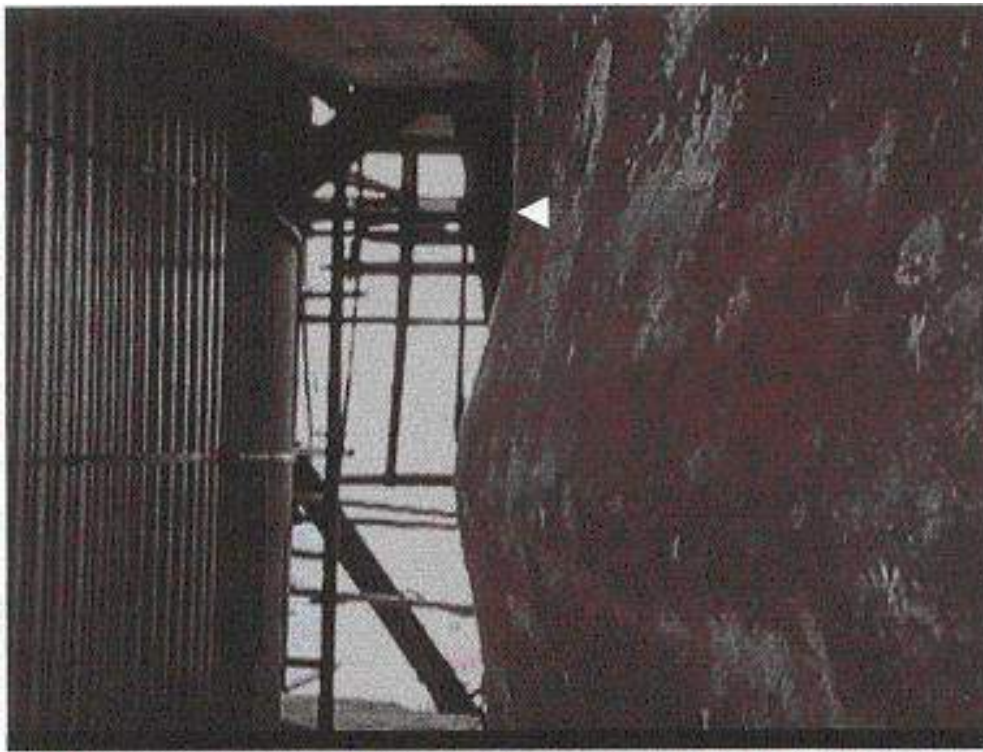
Figure 4-21 – Bulging in a skirt of a coke drum.

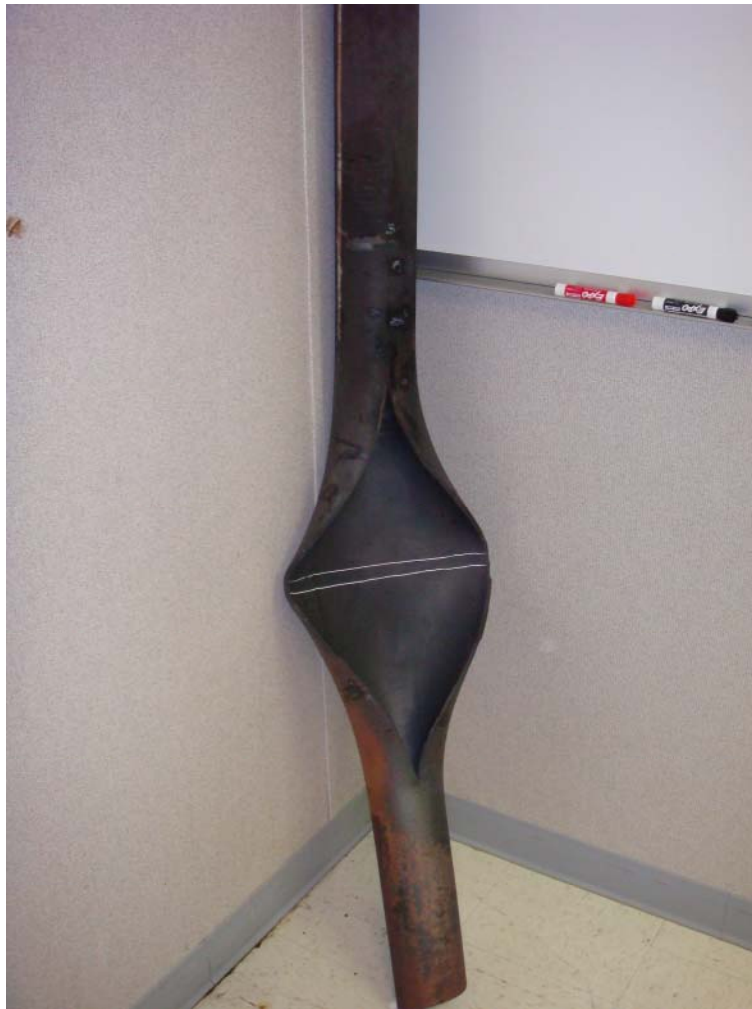
Figure 4-28 – Short term overheating failure of a vertical 4.5-in. OD, Schedule 160 2.25Cr-1Mo (SA335-P2) hydrocracker radiant that was 21 years old. Failure occurred due process side starvation with burners running.

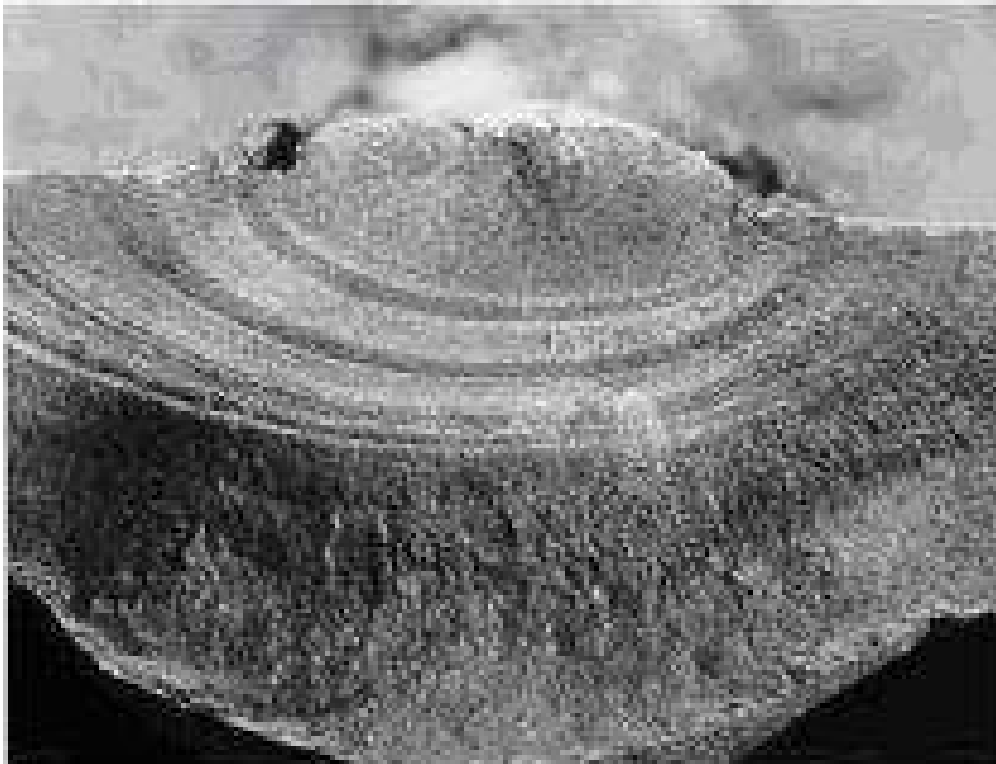
Figure 4-53 – Fatigue fracture surface of a carbon steel pipe.

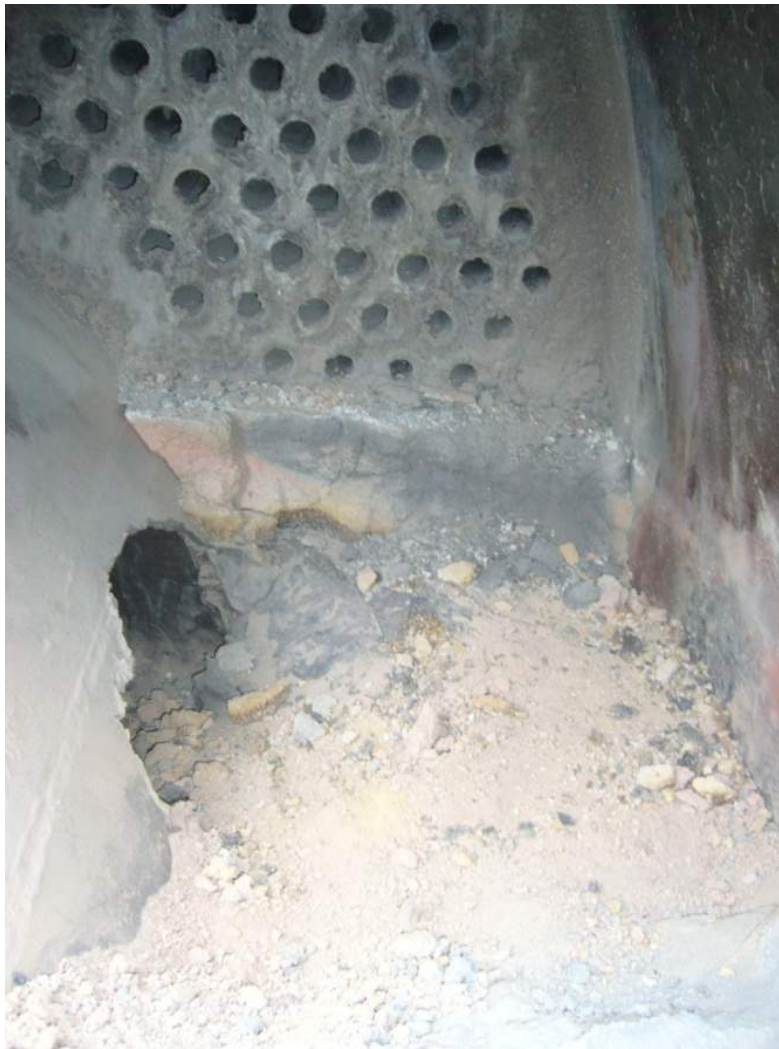
Figure 4-66 – Same as figure above when viewed from a different angle.

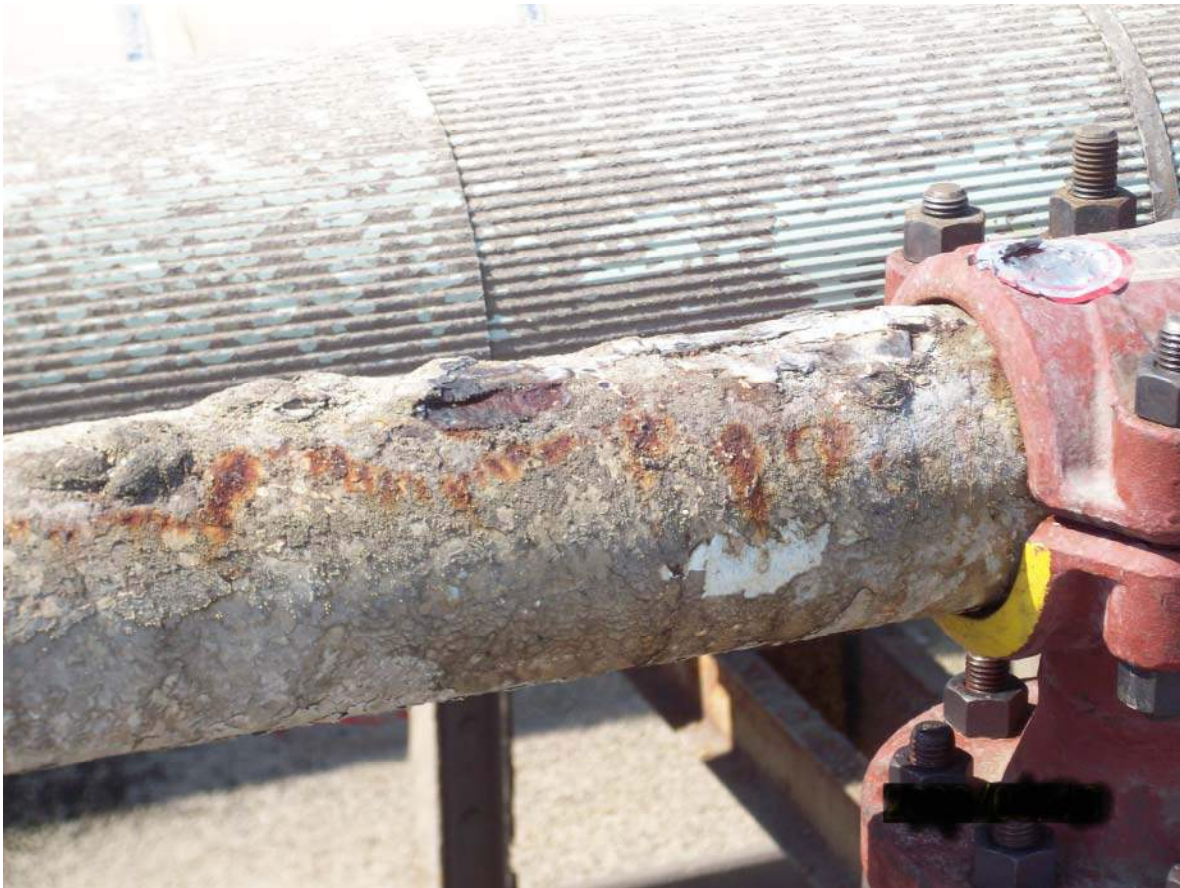
Figure 4-72 – Atmospheric Corrosion of an LPG line in close proximity to a cooling tower.

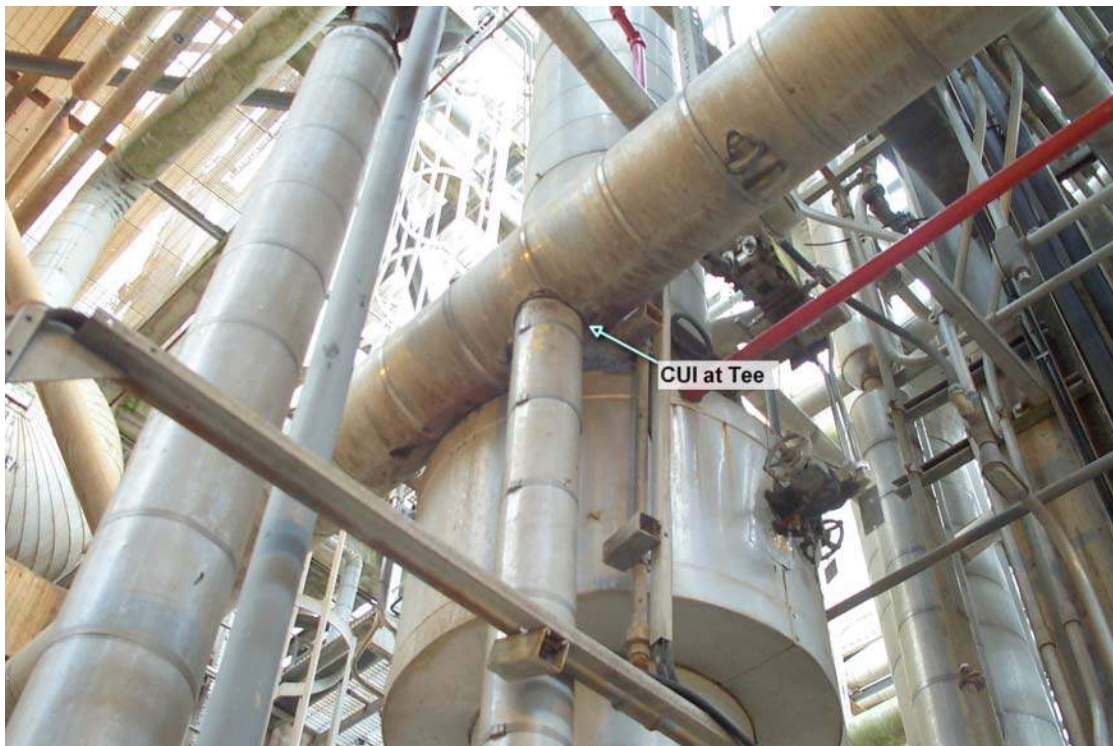
Figure 4-73 – Tee in a 1000 psig ethylene line before insulation removal.

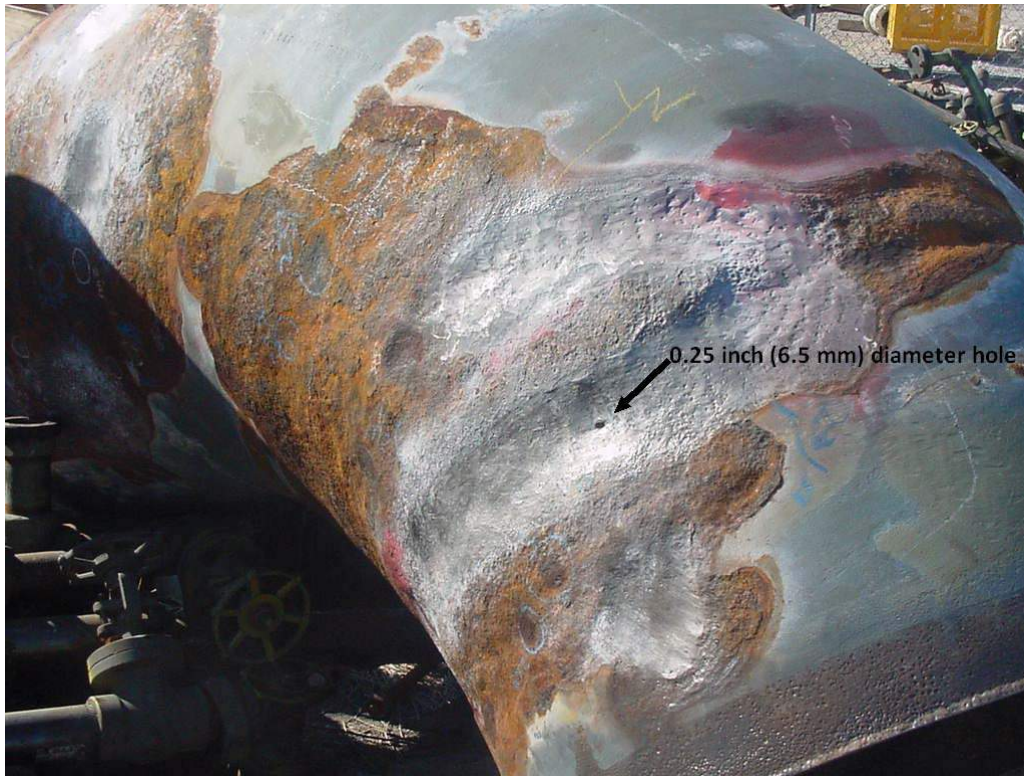
Figure 4-75 – CUI of a 30 inch CS Butadiene line showing highly localized corrosion which could only be found by stripping the entire line. Note the 0.25 in (6.5 mm) diameter hole at arrow.

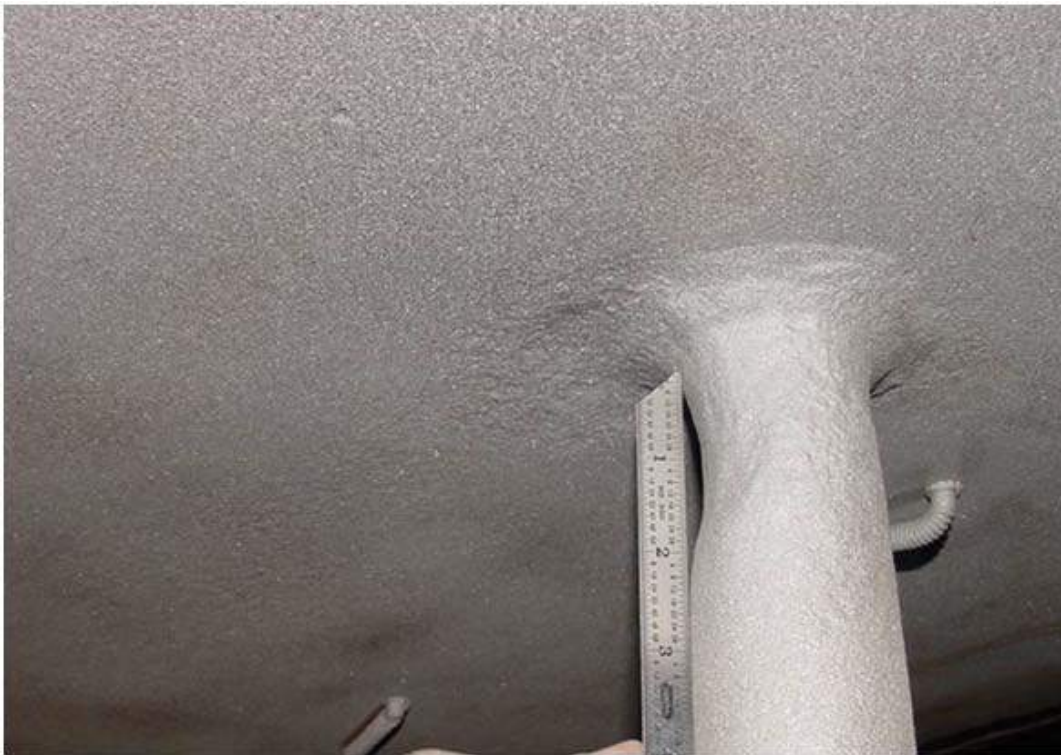
Figure 4-76 – CUI of nozzle on a bottom head.

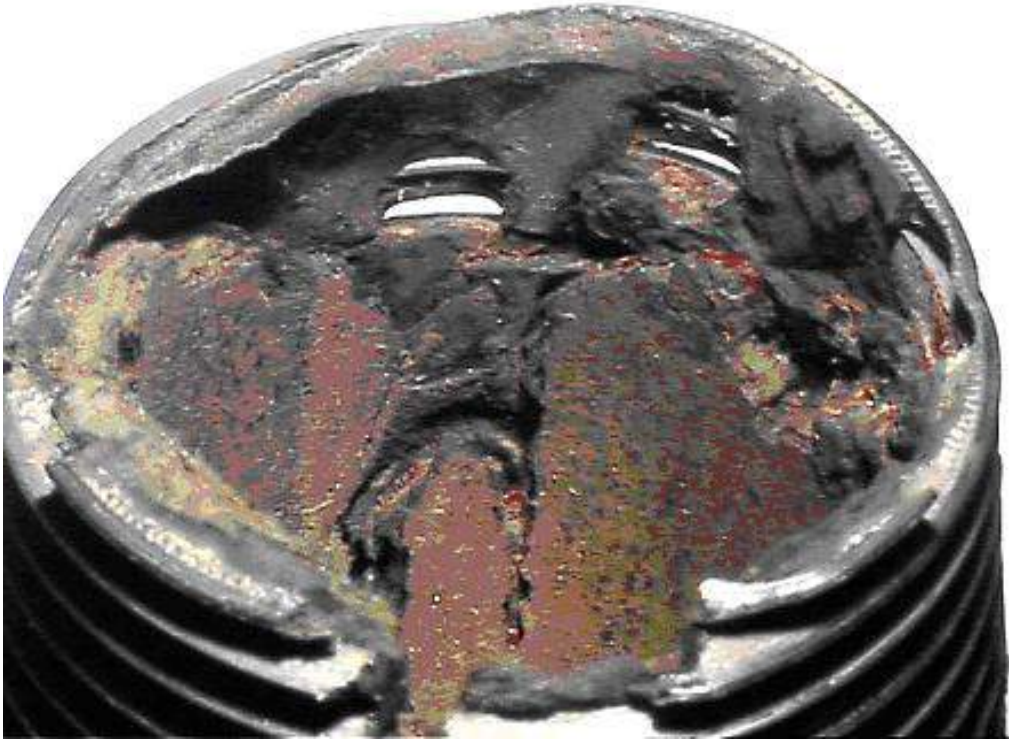
Figure 4-87 – CO₂ corrosion of CS pipe nipple in CO₂ contaminated water.

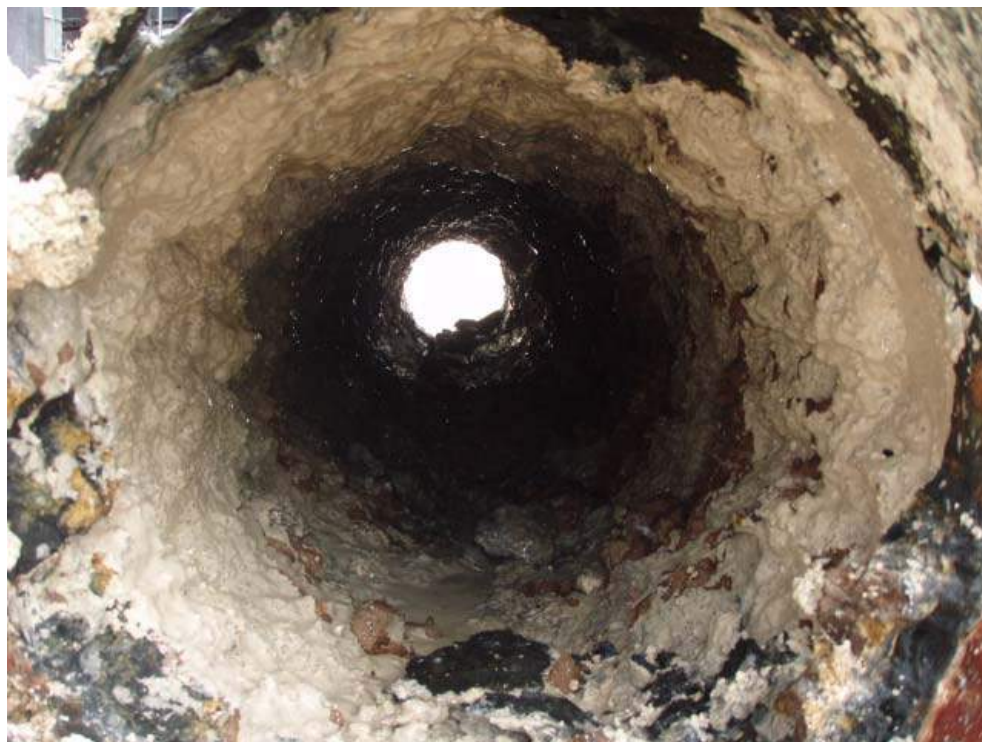
Figure 4-106 – View of concrete lining inside the failed line shown in Figure 105.

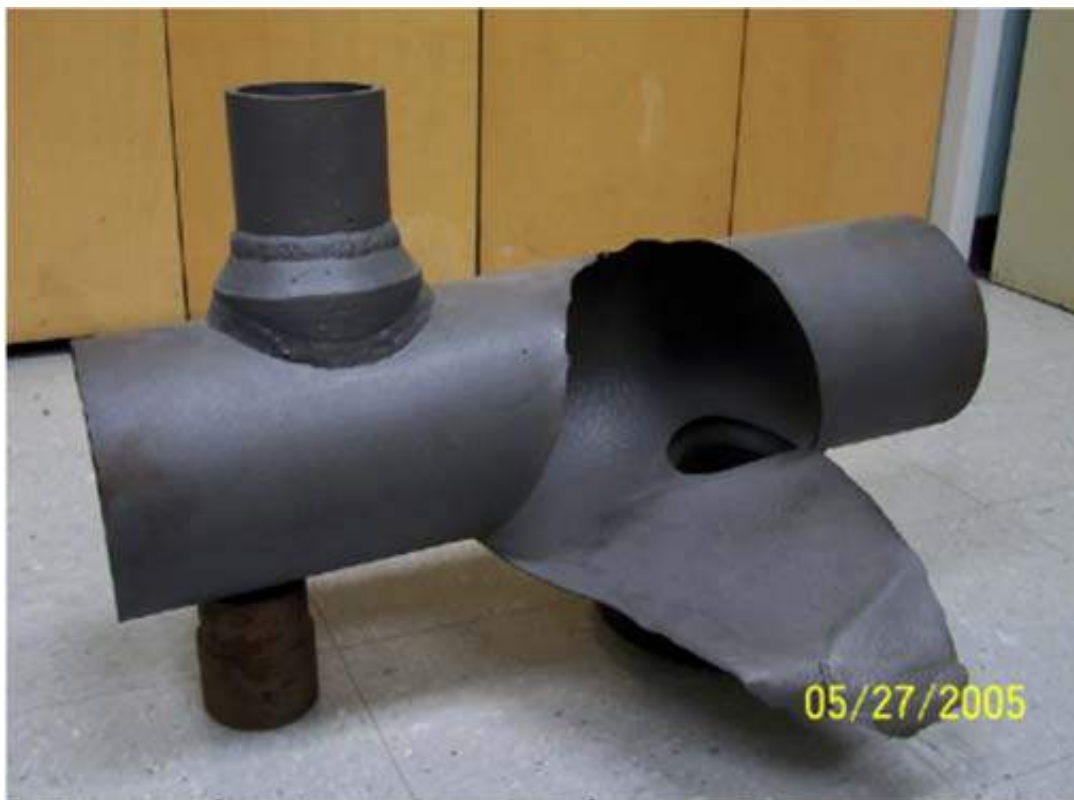
Figure 4-116 – Sulfidation failure of NPS 8 carbon steel pipe. Note the relatively uniform thinning that resulted in a sizeable rupture.

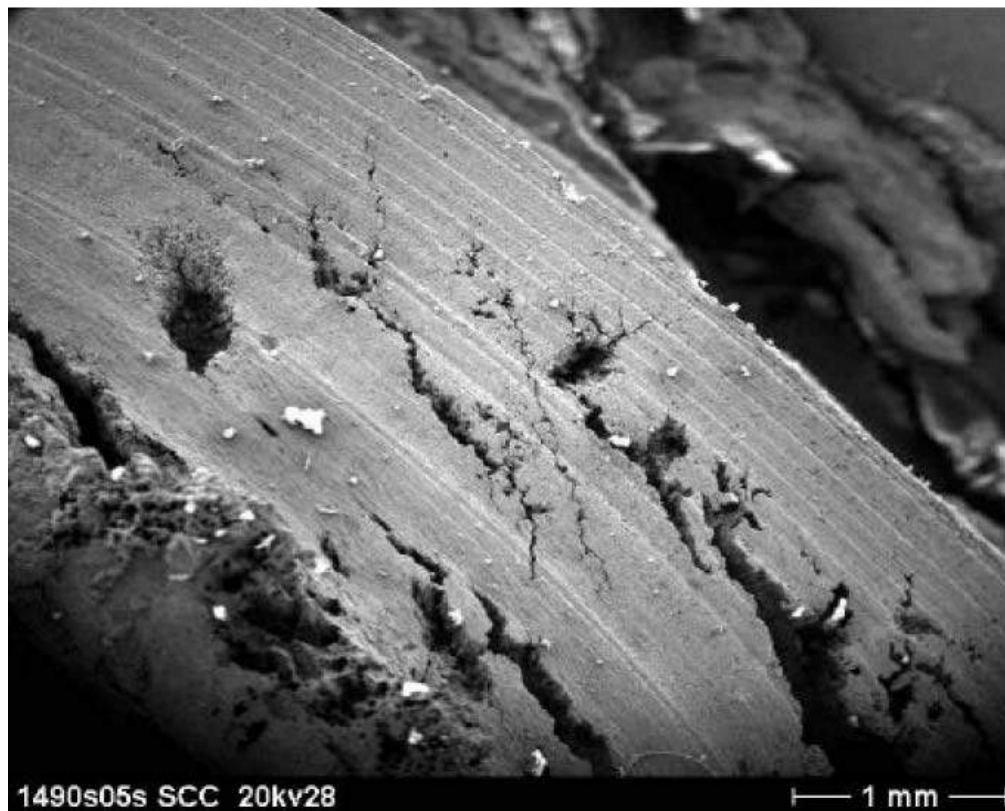
Figure 4-139 – Chloride SCC on the thread surface of a failed 303SS bolt.

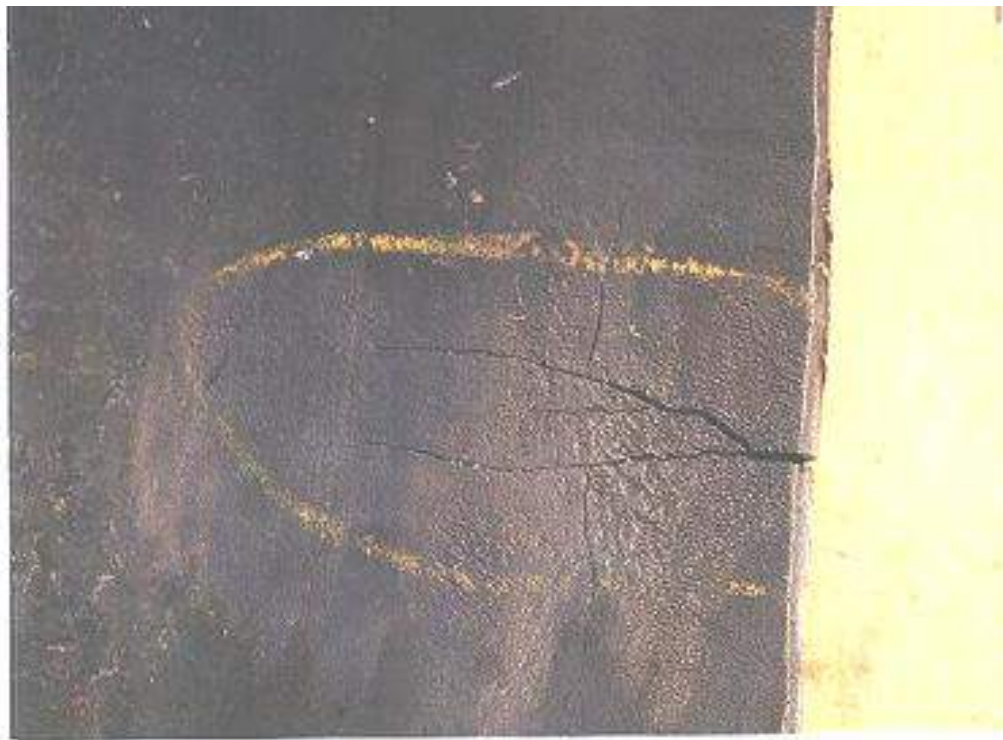
Figure 4-159 – Liquid metal embrittlement of Monel caused by mercury in an FCC gas plant overhead drum.

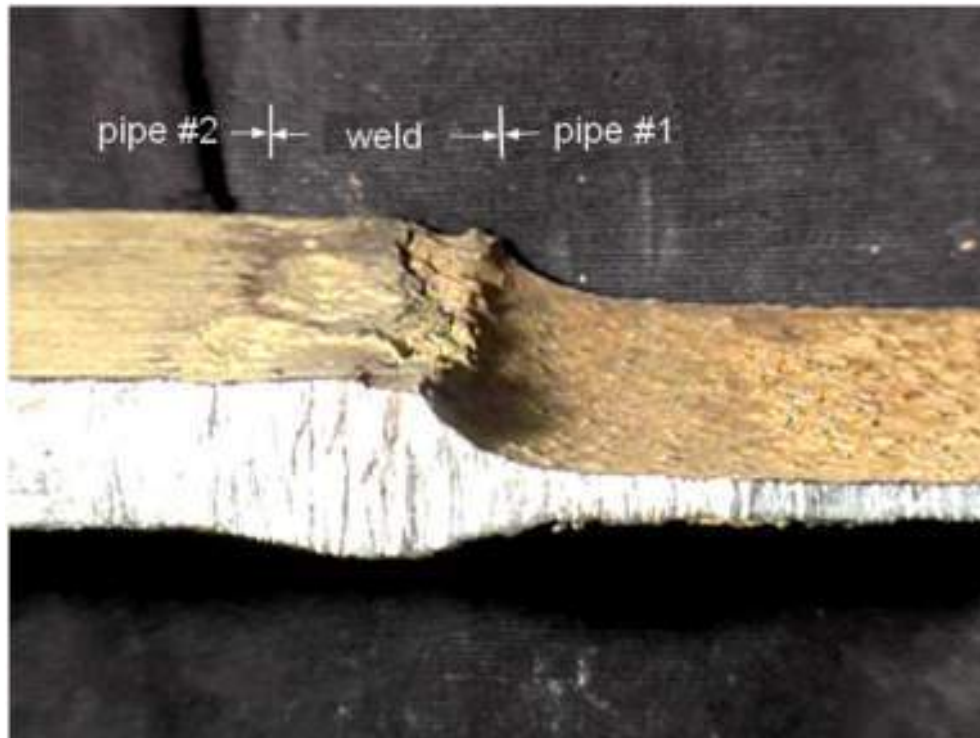
Figure 5-12 – Cross-section of a carbon steel pipe showing preferential corrosion of the pipe with high residual element content on the right, as compared to the low residual pipe section to the left of the weld (Reference 3).

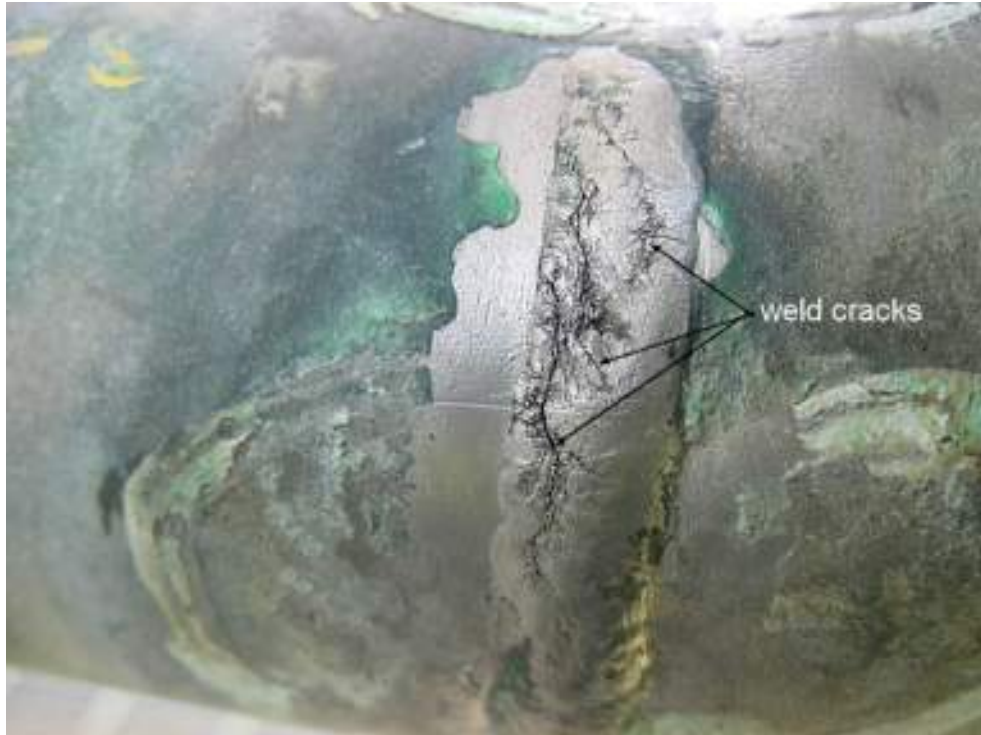
Figure 5-16 – HF stress corrosion cracking of Alloy 400 vent line in an acid dump system (Reference 8).

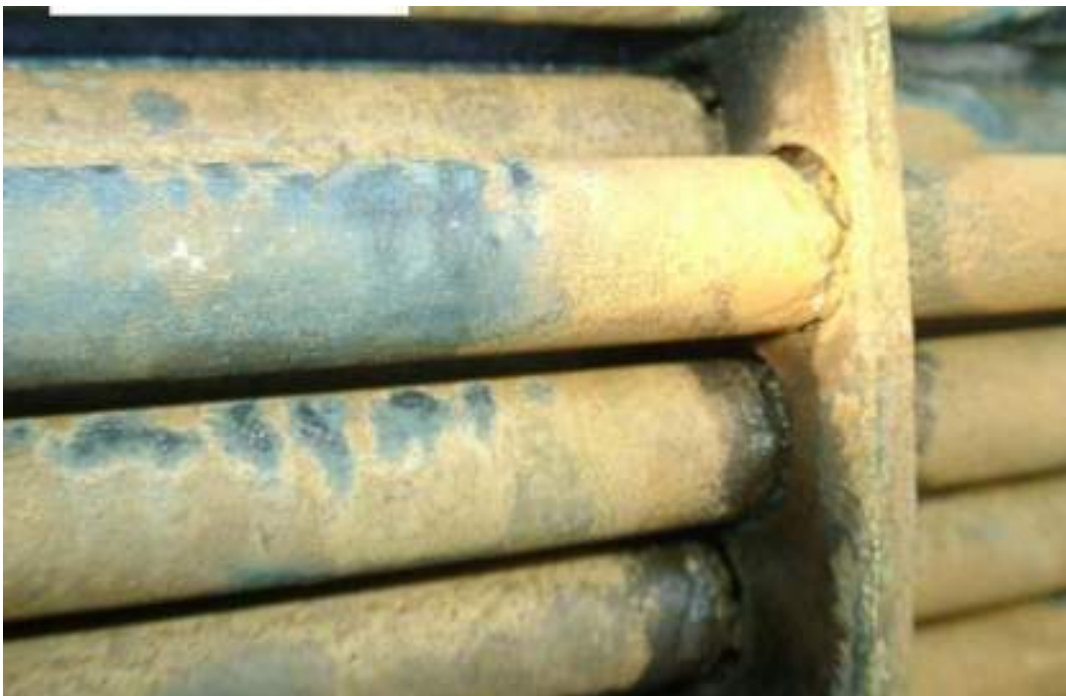
Figure 5-22 – Accelerated corrosion under a baffle.

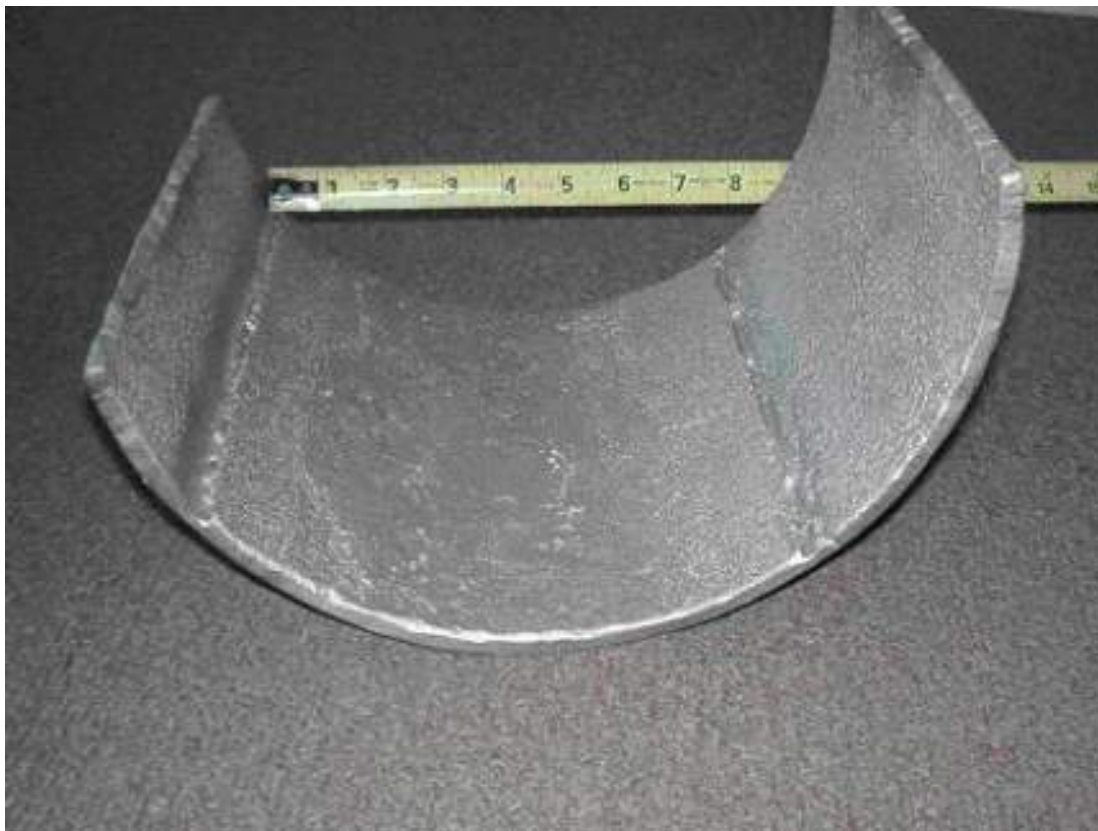
Figure 5-23 – Grooving corrosion in the carbon steel vapor line from an alkaline water wash drum in a sulfuric acid alkylation unit.

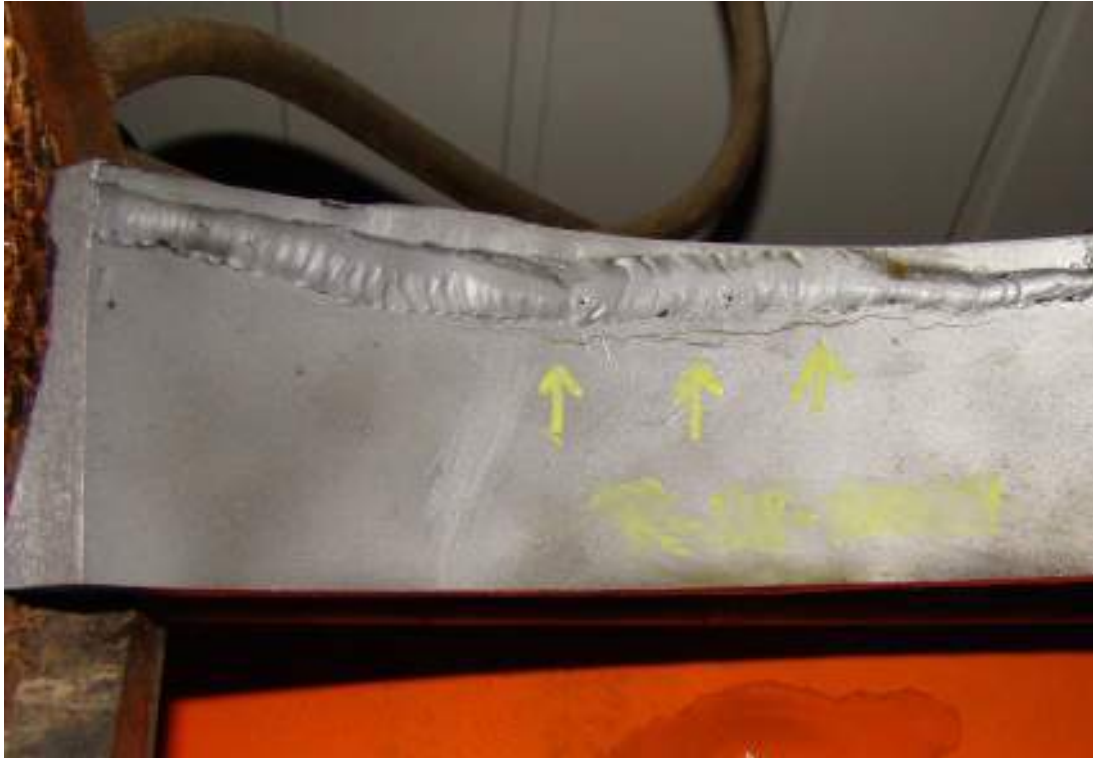
Figure 5-46 – Overhead interstage knockout drum vapor outlet nozzle.
